**Flood Control Project Maintenance  
Levee Inspections**

**Fall 2018 Levee Maintenance Deficiency Summary Report**

**Sacramento River Basin**

**Sutter Maintenance Yard Maintenance Area 0012**

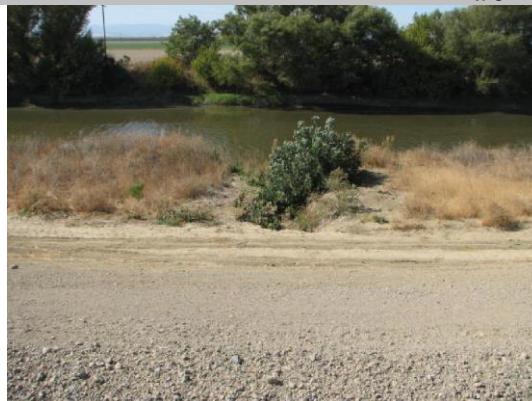
Photo 2 of 3 : UCIP\_FA\_2018\_51780\_68976.jpg

Outlet at WS toe.

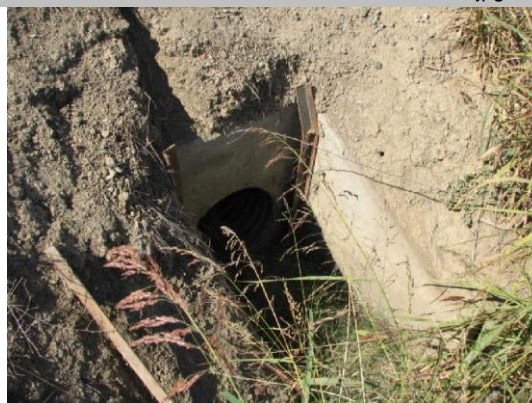
Photo 3 of 3 : UCIP\_FA\_2018\_51780\_68975.jpg

Concrete U shaped headwall on LS toe.

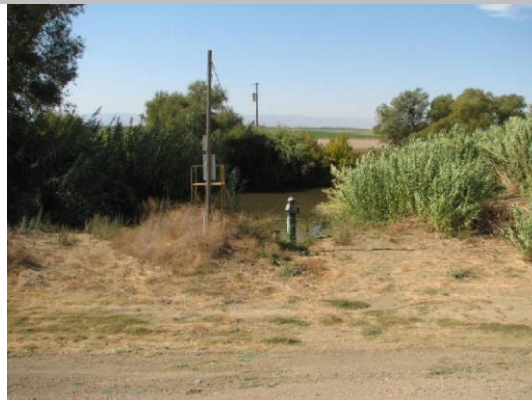
Photo 1 of 3 : UCIP\_FA\_2018\_51781\_68981.jpg

FS\_ID:51781  
DS\_ID:17148  
EP\_NO: 9382  
Repair Type: Non-Urgent  
Crossing Status: Found  
UCIP Comments: 5/2/2017 WS is being overgrown with vegetation. The rest of the crossing appears to be in good condition. (DWR Sutter Yard- A Freitag)10/17/2016 Vegetation is overgrowing the WS head wall near the pump. The rest of the crossing appears to be in good condition. (DWR Sutter Yard- A Freitag)5/31/2016 Crossing appears to be in good condition.5/4/2015 Crossing appears in good condition. No noticeable issues to report.6/17/2014 Same as last inspection.12/16/2013 Same as last inspection.7/16/2013 Same as last inspection.  
FIELD\_STRUCT\_DESC: 18-inch steel irrigation pipe through the levee, 3 feet below the crown. Pump, butterfly valve, and concrete headwall at the edge of the bank. Bank cobble revetted 10 feet on both the waterside (WS) and the landside (LS) of installation. 18-inch polyvinyl chloride (PVC) standpipe on the LS berm. Siphon breaker in 18-inch concrete riser on the LS shoulder. Service pole at the edge of the bank. (24-inch [HLM 1.53] authorized under Automatic Board Order (ABO) issued as Permit No. 9382, 1974 - Olen C. Bober) [Additional Reference(s): DWR Levee Log, 2005. USACE Sacramento O&M Manual 132, October 1959, (HLM 1.53)].

Pump, pole, and meter on WS toe.

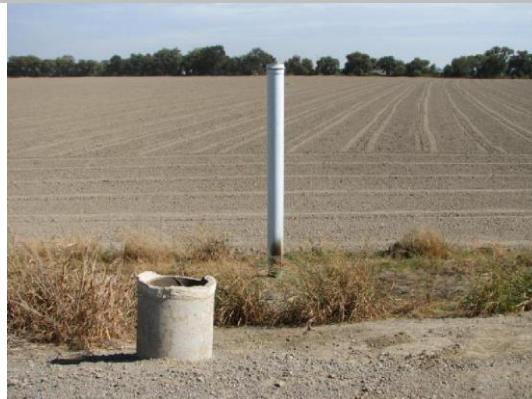
Photo 2 of 3 : UCIP\_FA\_2018\_51781\_68980.jpg

Concrete and PVC risers on LS.

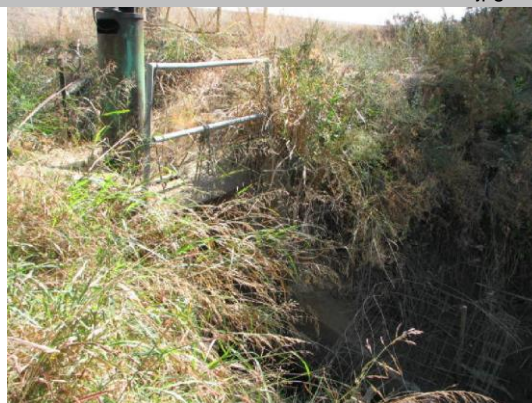
Photo 3 of 3 : UCIP\_FA\_2018\_51781\_68979.jpg

Comment Code						
Inspector Comment						
FS_ID:51781 DS_ID:17148 EP_NO: 9382 Repair Type: Non-Urgent Crossing Status: Found UCIP Comments: 5/2/2017 WS is being overgrown with vegetation. The rest of the crossing appears to be in good condition. (DWR Sutter Yard- A Freitag)10/17/2016 Vegetation is overgrowing the WS head wall near the pump. The rest of the crossing appears to be in good condition. (DWR Sutter Yard- A Freitag)5/31/2016 Crossing appears to be in good condition.5/4/2015 Crossing appears in good condition. No noticeable issues to report.6/17/2014 Same as last inspection.12/16/2013 Same as last inspection.7/16/2013 Same as last inspection. FIELD_STRUCT_DESC: 18-inch steel irrigation pipe through the levee, 3 feet below the crown. Pump, butterfly valve, and concrete headwall at the edge of the bank. Bank cobble revetted 10 feet on both the waterside (WS) and the landside (LS) of installation. 18-inch polyvinyl chloride (PVC) standpipe on the LS berm. Siphon breaker in 18-inch concrete riser on the LS shoulder. Service pole at the edge of the bank. (24-inch [HLM 1.53] authorized under Automatic Board Order (ABO) issued as Permit No. 9382, 1974 - Olen C. Bober) [Additional Reference(s): DWR Levee Log, 2005. USACE Sacramento O&M Manual 132, October 1959, (HLM 1.53)]. FS Date: 5/2/2017 1:47:19 PM

Pump and concrete headwall at WS toe.

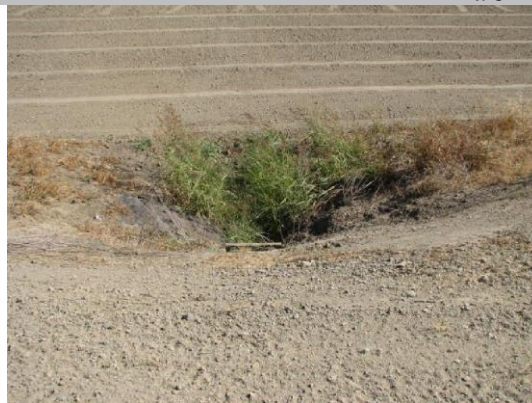
Photo 2 of 3 : UCIP\_FA\_2018\_51782\_68983.jpg

FS\_ID:51782  
DS\_ID:17149  
EP\_NO: 9382  
Repair Type: Non-Urgent  
Crossing Status: Found  
UCIP Comments: 5/2/2017 WS flapgate buried by sediment. Needs to be dug out. (DWR Sutter Yard- AFreitag)10/17/2016 Crossing appears to be in good condition. This is a gravity drain for the LS. (DWR Sutter Yard- AFreitag)5/31/2016 LS inlets was partially plugged. WS flapgate was clear of sediment and able to operate properly.5/4/2015 WS flapgate is blocked by sediment and unable to open. LS inlet is plugged by silt and wood chippings. Needs to be cleaned.6/17/2014 Flap gate was cleaned out and is fully closed. LS inlet still partially full of soil.12/16/2013 Same as last inspection. WS flapgate still needs to be cleaned out and shut.7/16/2013 Same as last inspection. Make sure flapgate is closed before highwater season.10/11/2012 Inlet on LS filled partially with soil. Outlet blocked with soil and the flap gate wont close.

Inlet on LS toe.

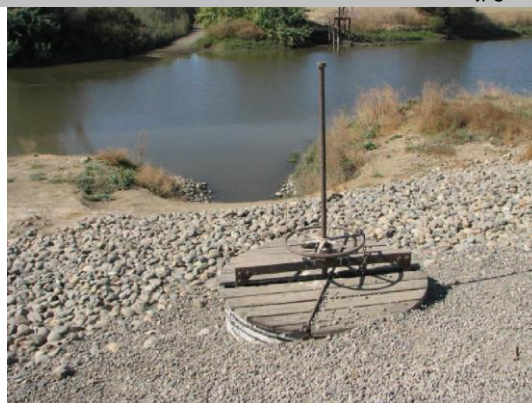
Photo 1 of 3 : UCIP\_FA\_2018\_51785\_68991.jpg

60-inch standpipe with slide gate on WS slope with outlet in background.

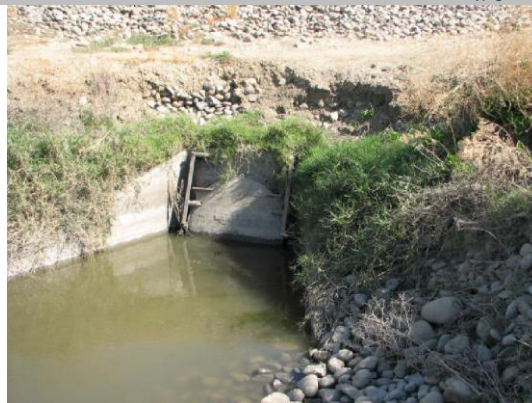
Photo 2 of 3 : UCIP\_FA\_2018\_51785\_68990.jpg

FS\_ID:51785  
DS\_ID:17150  
EP\_NO: 9387  
Repair Type: No Action Needed  
Crossing Status: Found  
UCIP Comments: 5/2/2017 Crossing appears to be in good condition. (DWR Sutter Yard- AFreitag)10/17/2016 Crossing appears to be in good condition. (DWR Sutter Yard- AFreitag)5/31/2016 Crossing appears to be in good condition. Attached photo showing location of LS inlet.5/4/2015 WS flapgate mostly underwater but could tell it was blocked open by something. LS inlet is located about 1/4 mile north along the side of the roadway.6/17/2014 Same as last inspection.12/16/2013 Pipe was flowing water and flap gate was being pushed open. Cannot verify if it will close all the way.7/16/2013 Same as last inspection. Was told inlet is about 1/4 mile down road way next to house. Will try to get coordinates for inlet.10/11/2012 No inlet could be located on LS. Flap gate partially blocked and will not close completely.

Flap gate and concrete headwall at WS toe.

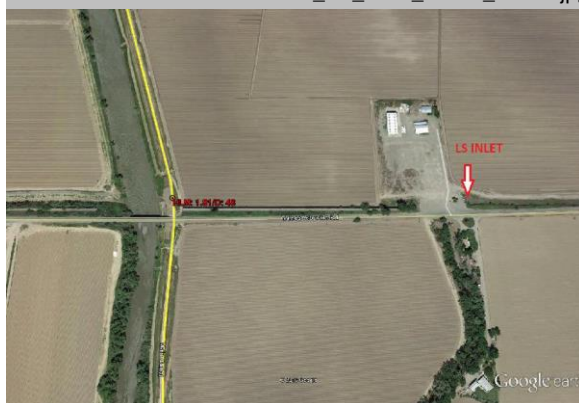
Photo 3 of 3 : UCIP\_FA\_2018\_51785\_75168.jpg

FS\_ID:51785  
DS\_ID:17150  
EP\_NO: 9387  
Repair Type: No Action Needed  
Crossing Status: Found  
UCIP Comments: 5/2/2017 Crossing appears to be in good condition. (DWR Sutter Yard- A Freitag) 10/17/2016 Crossing appears to be in good condition. (DWR Sutter Yard- A Freitag) 5/31/2016 Crossing appears to be in good condition. Attached photo showing location of LS inlet. 5/4/2015 WS flapgate mostly underwater but could tell it was blocked open by something. LS inlet is located about 1/4 mile north along the side of the roadway. 6/17/2014 Same as last inspection. 12/16/2013 Pipe was flowing water and flap gate was being pushed open. Cannot verify if it will close all the way. 7/16/2013 Same as last inspection. Was told inlet is about 1/4 mile down road way next to house. Will try to get coordinates for inlet. 10/11/2012 No inlet could be located on LS. Flap gate partially blocked and will not close completely.

Arrow showing location of LS inlet

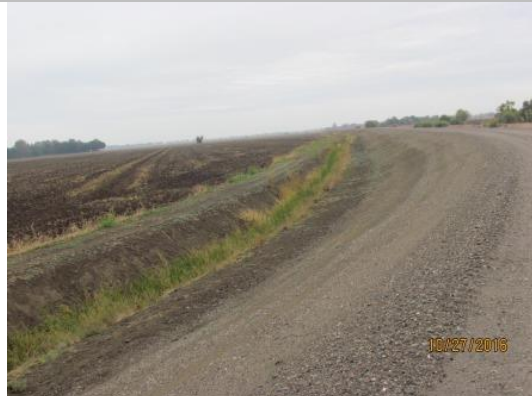
Photo 1 of 1 : FA\_2018\_MA0012\_299\_34\_20180904\_00003.jpg

LM Start	2.58	Rating **	U	Issue No.	34
LM End	3.01	Issue Type +	En	Location *	LS
Category	Earthen Levee			GPS Latitude/Longitude	
				Start	End
Item	Encroachments			39.067342°	39.072267°
				-122.009530°	-122.014443°
DWR ID	DWR_MA0012_01_f_2016_34				
Comment Code					
DT : Ditch					
Inspector Comment

View of a ditch along the landside toe.

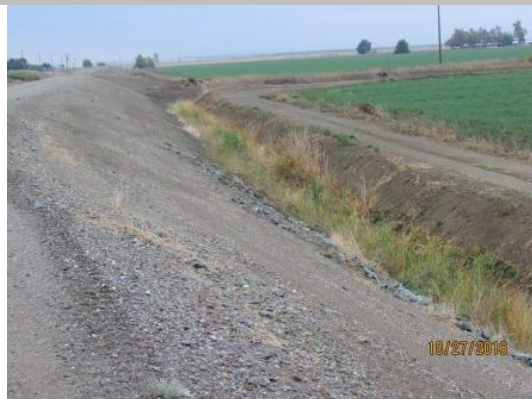
Photo 1 of 1 : FA\_2018\_MA0012\_299\_1\_20180904\_00001.jpg

LM Start	3.01	Rating **	U	Issue No.	1
LM End	3.68	Issue Type +	En	Location *	LS
Category	Earthen Levee			GPS Latitude/Longitude	
				Start	End
Item	Encroachments			39.072267 °	39.081684 °
				-122.014453 °	-122.016243 °
DWR ID	DWR_MA0012_01_s_2012_1				
Comment Code					
DT : Ditch					
Inspector Comment

View of a ditch along the landside toe.

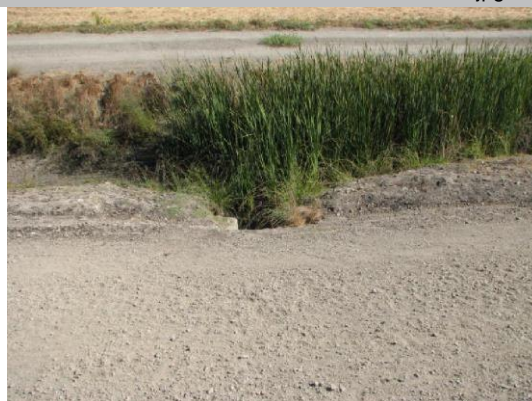
Photo 1 of 3 : UCIP\_FA\_2018\_51788\_69002.jpg

Concrete headwall at LS toe.

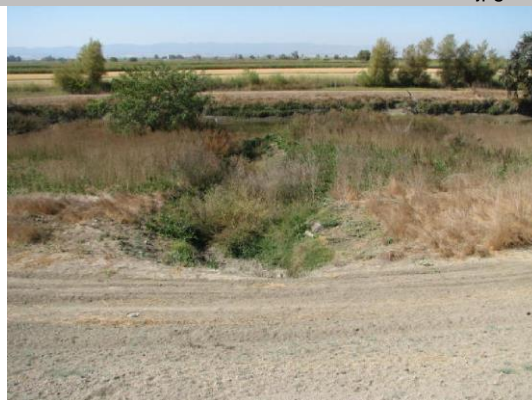
Photo 2 of 3 : UCIP\_FA\_2018\_51788\_69001.jpg

Drainage Swale on WS toe.

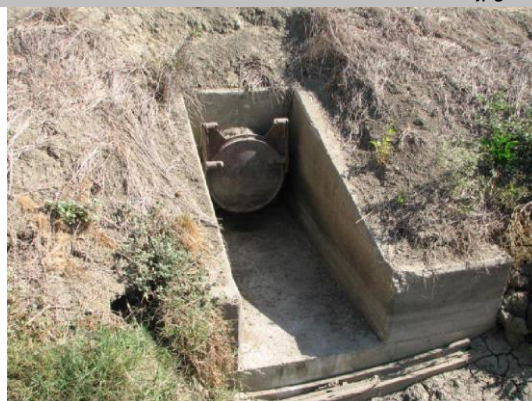
Photo 3 of 3 : UCIP\_FA\_2018\_51788\_69000.jpg

Concrete headwall and flap gate at WS toe.

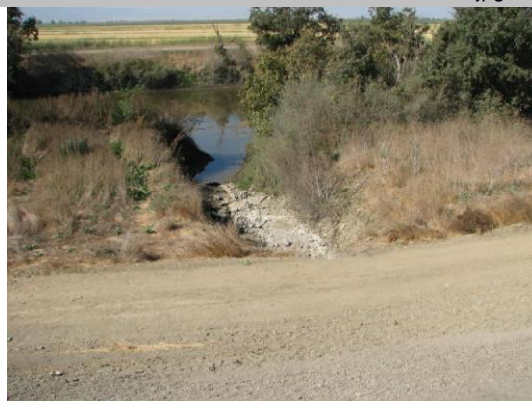
Photo 1 of 3 : UCIP\_FA\_2018\_51791\_69014.jpg

Outlet at WS toe.

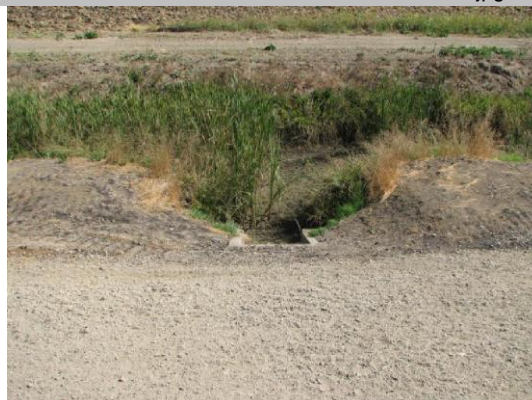
Photo 2 of 3 : UCIP\_FA\_2018\_51791\_69013.jpg

Concrete U shaped headwall on LS toe.

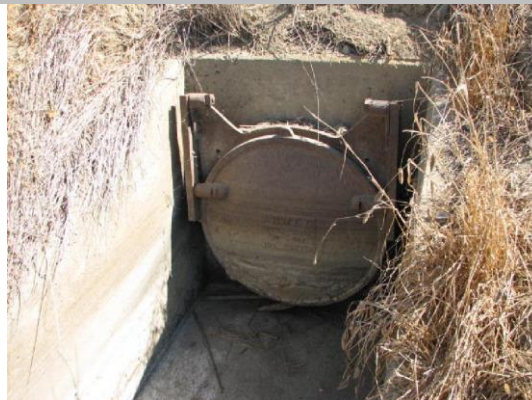
Photo 3 of 3 : UCIP\_FA\_2018\_51791\_69012.jpg

Concrete U shaped headwall and flap gate on WS toe.

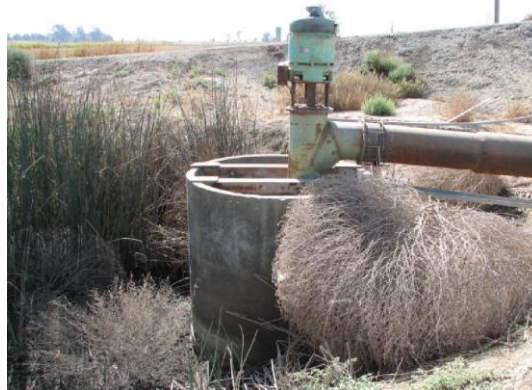
Photo 1 of 3 : UCIP\_FA\_2018\_51792\_69017.jpg

Pump on Concrete riser at LS toe.

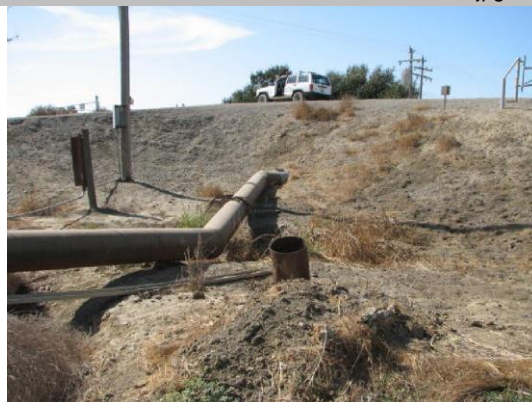
Photo 2 of 3 : UCIP\_FA\_2018\_51792\_69016.jpg

Pipe through levee at LS slope.

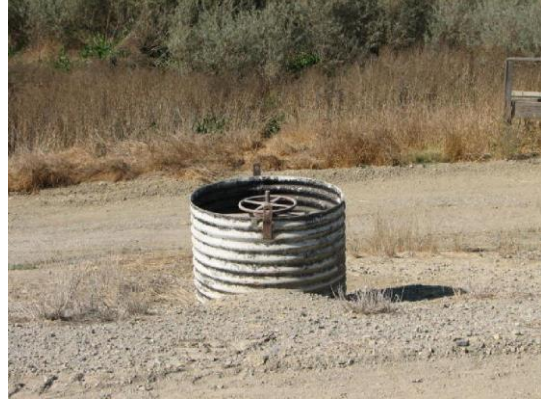
Photo 3 of 3 : UCIP\_FA\_2018\_51792\_69015.jpg

36-inch CMP riser with Slide gate on WS shoulder.

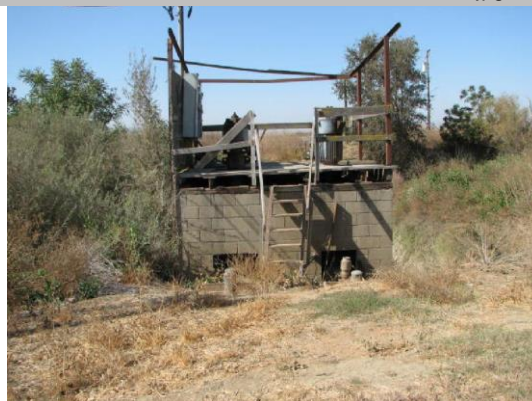
Photo 2 of 3 : UCIP\_FA\_2018\_51794\_69022.jpg

Pumping plant on WS toe.

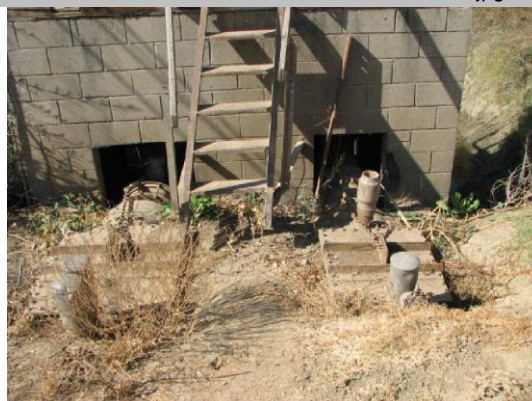
Photo 3 of 3 : UCIP\_FA\_2018\_51794\_69021.jpg

Pipe on seft side of photo.

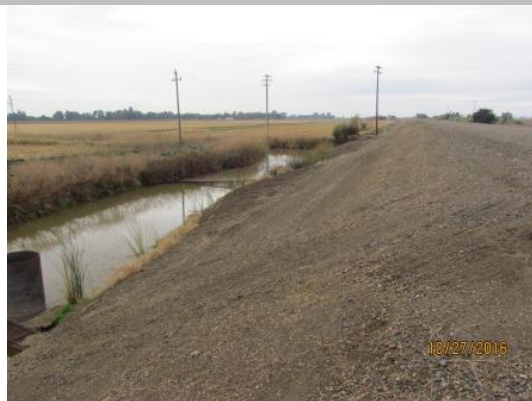
Photo 1 of 1 : FA\_2018\_MA0012\_299\_4\_20180904\_00002.jpg

LM Start	4.72	Rating **	M	Issue No.	4
LM End	4.77	Issue Type +	En	Location *	LS
Category	Earthen Levee			GPS Latitude/Longitude	
				Start	End
Item	Encroachments			39.096839 °	39.097455 °
				-122.015568 °	-122.015581 °
DWR ID	DWR_MA0012_01_s_2012_4				
Comment Code					
DT : Ditch					
Inspector Comment

View of a ditch along the landside toe.

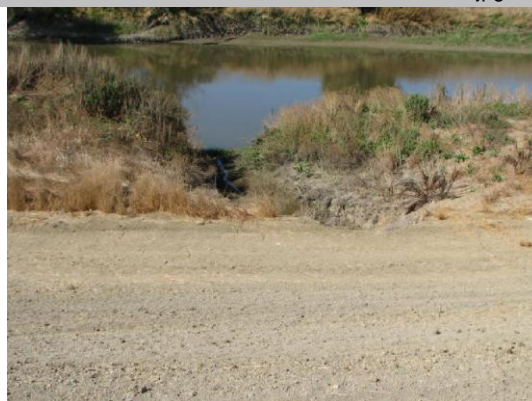
Photo 1 of 3 : UCIP\_FA\_2018\_51795\_69026.jpg

Comment Code						
Inspector Comment						
FS_ID:51795						
DS_ID:17158						
EP_NO: 9390						
Repair Type: No Action Needed						
Crossing Status: Found						
UCIP Comments: 5/2/2017 Crossing appears to be in good condition. There is minor sediment build up in front of the WS flap gate/ (DWR Sutter Yard- AFreitag)10/17/2016 Crossing appears to be in good condition. (DWR Sutter Yard- AFreitag)5/31/2016 Crossing appears to be in good condition.5/4/2015 Corssing appears to be in good condition. No noticeable issues to report.6/17/2014 Same as last inspection.12/16/2013 Same as last inspection.7/16/2013 New flapgate installed on WS pipe end.10/11/2012 Flap gate broken on WS, Pipe shows significant rust at outlet. This is a good candidate for video inspection.						
FIELD_STRUCT_DESC: 36-inch corrugated metal drainage pipe though the levee, 20 feet below the crown. Pump on metal pier in landside (LS) channel. 40-inch steel standpipe at the LS toe. Flap gate and concrete headwall on the waterside (WS). Concrete headwall on the LS. (36-inch pipe authorized under Automatic Board Order (ABO) issued as Permit No. 9390, 1974 - Annie D. Propfe). [Additional Reference(s): DWR Levee Log, 2005. USACE Sacramento O&M Manual 132, October 1959, (HLM 4.87)].

Outlet channel on WS toe.

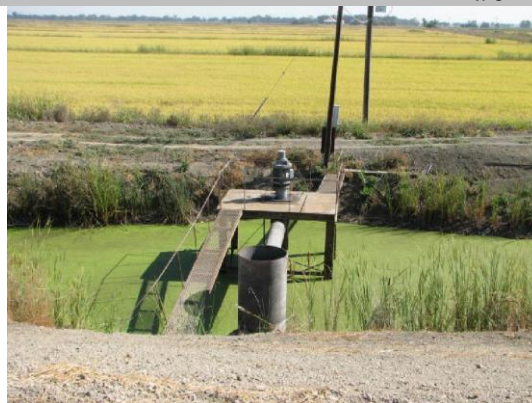
Photo 2 of 3 : UCIP\_FA\_2018\_51795\_69025.jpg

Pump, walkway, and standpipe on LS toe.

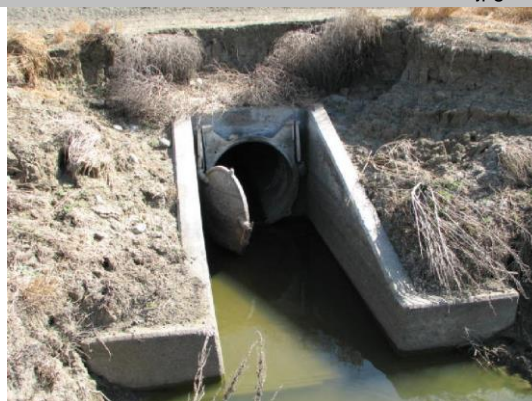
Photo 3 of 3 : UCIP\_FA\_2018\_51795\_69024.jpg

Comment Code						
Inspector Comment						
FS_ID:51795						
DS_ID:17158						
EP_NO: 9390						
Repair Type: No Action Needed						
Crossing Status: Found						
UCIP Comments: 5/2/2017 Crossing appears to be in good condition. There is minor sediment build up in front of the WS flap gate/ (DWR Sutter Yard- A/Freitag)10/17/2016 Crossing appears to be in good condition. (DWR Sutter Yard- A/Freitag)5/31/2016 Crossing appears to be in good condition.5/4/2015 Corssing appears to be in good condition. No noticeeable issues to report.6/17/2014 Same as last inspection.12/16/2013 Same as last inspection.7/16/2013 New flapgate installed on WS pipe end.10/11/2012 Flap gate broken on WS, Pipe shows significant rust at outlet. This is a good candidate for video inspection.						
FIELD_STRUCT_DESC: 36-inch corrugated metal drainage pipe though the levee, 20 feet below the crown. Pump on metal pier in landside (LS) channel. 40-inch steel standpipe at the LS toe. Flap gate and concrete headwall on the waterside (WS). Concrete headwall on the LS. (36-inch pipe authorized under Automatic Board Order (ABO) issued as Permit No. 9390, 1974 - Annie D. Propfe). [Additional Reference(s): DWR Levee Log, 2005. USACE Sacramento O&M Manual 132, October 1959, (HLM 4.87)].

Flap gate in concrete U-shaped headwall on WS toe.

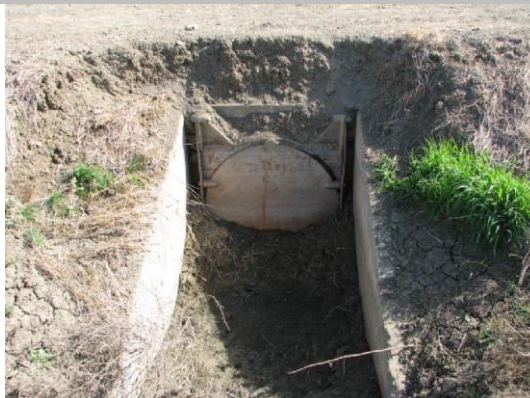
Photo 3 of 3 : UCIP\_FA\_2018\_51796\_69028.jpg

Comment Code						
Inspector Comment						
FS_ID:51796 DS_ID:17191 EP_NO: N/A Repair Type: Non-Urgent Crossing Status: Found UCIP Comments: 5/2/2017 WS headwall and flapgate almost completely buried with only a small portion of the head wall visible. LS end is buried and unable to be located. (DWR Sutter Yard-AFreitag)10/17/2016 WS flap gate is still silted over and LS inlet is heavily vegetated and unable to be inspected. (DWR Sutter Yard-AFreitag)9/29/2016 Crosssing has been downgraded from Urgent to Non-Urgent WS flap gate is closed shut due to sediment build up. For flood season flap gate is required to be closed. Need to coordinate with owner to remove sediment from WS to have WS flap gate be operable after flood season. (DWR UCIP - omagana)5/31/2016 WS pipe end was mostly underwater but it appears to still be silted over. (DWR Sutter Yard - afreitag)5/4/2015 WS flapgate is blocked by sediment and unable to open. LS inlet is hidden by sediment and heavy vegetation and unable to be located. Needs to be cleared. (DWR Sutter Yard - afreitag)6/17/2014 Same as last inspection. (DWR Sutter Yard - afreitag)12/16/2013 Same as last inspection. (DWR Sutter Yard - afreitag)7/16/2013 Same as last inspection. (DWR Sutter Yard - afreitag)10/11/2012 Pipe is clogged at both the inlet and outlet. Good candidate for video inspection. (DWR UCIP - wwylie) FIELD_STRUCT_DESC: 48-inch corrugated metal drainage pipe through the levee, approximately 15 feet below the crown. Concrete headwalls on both the waterside (WS) and the landside (LS) ends with an automatic drainage gate on the WS. [Additional Reference(s): USACE Sacramento O&M Manual 132, October 1959, (HLM 5.12)]. FS Date: 5/2/2017 2:31:39 PM

Concrete U shaped headwall and flap gate on WS toe.

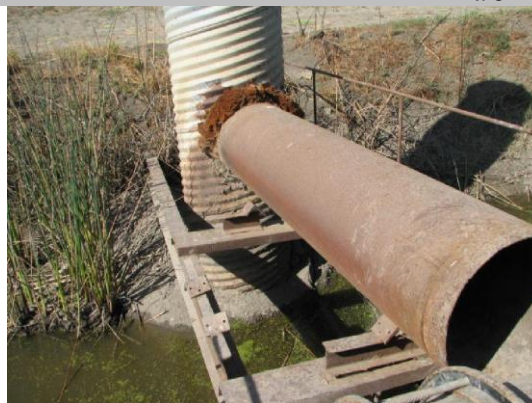
Photo 2 of 3 : UCIP\_FA\_2018\_51797\_69033.jpg

36-inch CM standpipe with steel pipe extension for weir on LS toe.

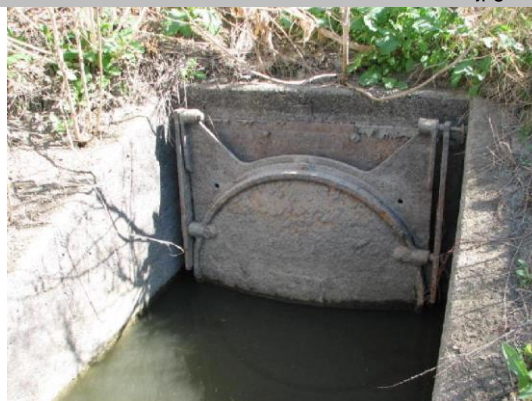
Photo 3 of 3 : UCIP\_FA\_2018\_51797\_69032.jpg

Comment Code						
Inspector Comment						
FS_ID:51797						
DS_ID:17190						
EP_NO: N/A						
Repair Type: No Action Needed						
Crossing Status: Found						
UCIP Comments: 5/2/2017 Crossing appears to be in good condition. (DWR Sutter Yard- A Freitag)10/17/2016 Crossing appears to be in good condition. Pipe was field verified to be 48inch cmp. (DWR Sutter Yard- A Freitag)5/31/2016 Crossing appears to be in good condition.5/4/2015 Corssing appears to be in good condition. No noticeable issues to report.6/17/2014 Same as last inspection.12/16/2013 Same as last inspection.7/16/2013 Same as last inspection.						
FIELD_STRUCT_DESC: 48-inch corrugated metal drainage pipe through the levee, approximately 22 feet below the crown. Concrete headwalls at both the waterside (WS) and the landside (LS) ends with flap gate on the WS. 36-inch corrugated metal pipe (CMP) riser on the LS toe with steel pipe extension for overflow weir of LS ditch. Walkway and pump not associated with this crossing. (Automatic board order (ABO) issued as Permit No. 8234, 1972 - Glenn Irrigation District, for 36-inch, not 48-inch). [Additional Reference(s): USACE Sacramento O&M Manual 132, October 1959, (HLM 6.04, Drawing No. 50-4-3081, Sheet 16)].

Flap gate in concrete U-shaped headwall at WS toe.

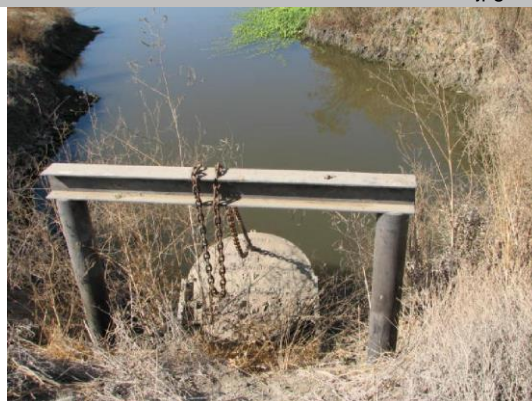
Photo 1 of 3 : UCIP\_FA\_2018\_51798\_69042.jpg

Comment Code					
Inspector Comment					
FS_ID:51798 DS_ID:17161 EP_NO: 9390 Repair Type: No Action Needed Crossing Status: Found UCIP Comments: 5/2/2017 Crossing appears to be in good condition. (DWR Sutter Yard- AFreitag)10/17/2016 Crossing appears to be in good condition. (DWR Sutter Yard- AFreitag)5/31/2016 Crossing appears to be in good condition.5/4/2015 Corssing appears to be in good condition. No noticeable issues to report.6/17/2014 Same as last inspection.12/16/2013 Same as last inspection.7/16/2013 Same as last inspection. FIELD_STRUCT_DESC: 48-inch corrugated metal drainage pipe through the levee, 20.3 feet below the crown. Concrete headwall and cobble revetted spillway on the waterside (WS). Slide gate in a 60-inch corrugated metal pipe (CMP) riser on the WS slope. Concrete headwall located on the landside (LS). (48-inch pipe authorized under Automatic Board Order (ABO) issued as Permit No. 9390, 1974 - Annie D. Propfe). [Additional Reference(s): DWR Levee Log, 2005. USACE Sacramento O&M Manual 132, October 1959, (HLM 6.10)]. FS Date: 5/2/2017 2:34:03 PM

48-inch flap gate on WS toe.

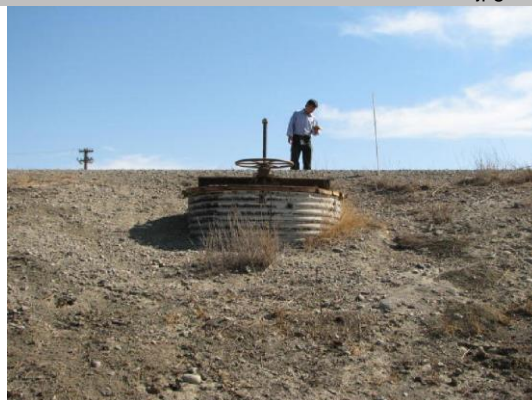
Photo 2 of 3 : UCIP\_FA\_2018\_51798\_69041.jpg

60-inch CMP riser with slide gate on WS slope.

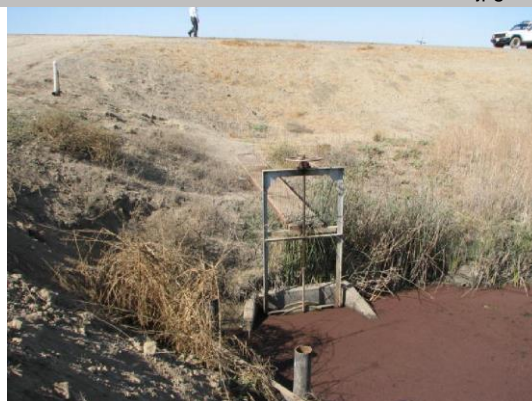
Photo 3 of 3 : UCIP\_FA\_2018\_51798\_69040.jpg

Comment Code						
Inspector Comment						
FS_ID:51798						
DS_ID:17161						
EP_NO: 9390						
Repair Type: No Action Needed						
Crossing Status: Found						
UCIP Comments: 5/2/2017 Crossing appears to be in good condition. (DWR Sutter Yard- A Freitag)10/17/2016 Crossing appears to be in good condition. (DWR Sutter Yard- A Freitag)5/31/2016 Crossing appears to be in good condition.5/4/2015 Corssing appears to be in good condition. No noticeable issues to report.6/17/2014 Same as last inspection.12/16/2013 Same as last inspection.7/16/2013 Same as last inspection.						
FIELD_STRUCT_DESC: 48-inch corrugated metal drainage pipe through the levee, 20.3 feet below the crown. Concrete headwall and cobble revetted spillway on the waterside (WS). Slide gate in a 60-inch corrugated metal pipe (CMP) riser on the WS slope. Concrete headwall located on the landside (LS). (48-inch pipe authorized under Automatic Board Order (ABO) issued as Permit No. 9390, 1974 - Annie D. Propfe). [Additional Reference(s): DWR Levee Log, 2005. USACE Sacramento O&M Manual 132, October 1959, (HLM 6.10)].

Concrete headwall with slide gate at LS toe.

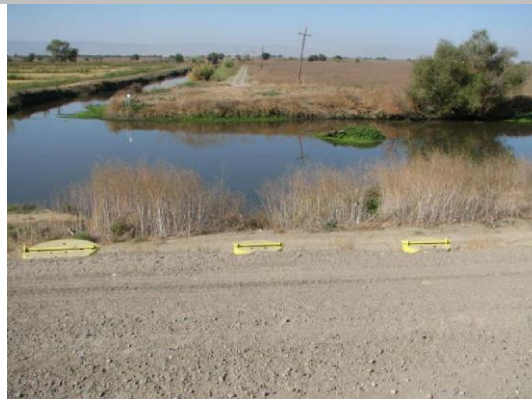
Photo 2 of 3 : UCIP\_FA\_2018\_51800\_69060.jpg

Comment Code					
Inspector Comment					
FS_ID:51800 DS_ID:20715 EP_NO: 13699 Repair Type: Non-Urgent Crossing Status: Found UCIP Comments: 5/2/2017 Pipe appears to be in good condition. Minor erosion above the LS pump house. (DWR Sutter Yard-AFreitag)10/17/2016 Crossing appears to be in good condition.  5/31/2016 Crossing appears to be in good condition.5/4/2015 Corssing appears to be in good condition. No noticeable issues to report.6/17/2014 Same as last inspection.12/16/2013 Same as last inspection.7/16/2013 Same as last inspection.10/11/2012 Oil leakage around pump. FIELD_STRUCT_DESC: 1 of 2: 20-inch soil proofed steel drainage pipe through the levee, 4.4 feet below the crown. Cobble revetted sump located on the waterside (WS). Siphon breaker in a 24-inch metal riser on the WS shoulder. Pump house at the landside (LS) toe. This crossing replaces the previous 18-inch pipe listed in the O&M manual, see DS_ID 17162. (Permit No. 13699, 1984 - Davis Ranches). [Additional Reference(s): USACE Sacramento O&M Manual 132, October 1959, (HLM 6.13)]. FS Date: 5/2/2017 2:35:14 PM

Siphon Breaker on WS shoulder.

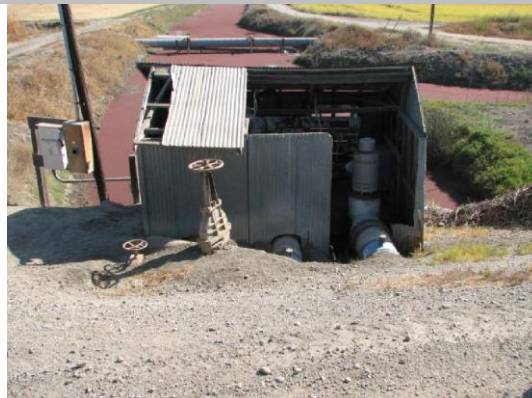
Photo 2 of 3 : UCIP\_FA\_2018\_51801\_69063.jpg

Comment Code						
Inspector Comment						
FS_ID:51801 DS_ID:20716 EP_NO: 13699 Repair Type: Non-Urgent Crossing Status: Found UCIP Comments: 5/2/2017 Pipe appears to be in good conition. Minor erosion above the LS pump house. (DWR Sutter Yard-AFreitag)10/17/2016 Crossing appears to be in good condition. (DWR Sutter Yard- AFreitag)5/31/2016 Crossing appears to be in good condition.5/4/2015 Corssing appears to be in good condition. No noticeable issues to report.6/17/2014 Same as last inspection.12/16/2013 Same as last inspection.7/16/2013 Same as last inspection.10/11/2012 Oil leaks at pump head. FIELD_STRUCT_DESC: 2 of 2: 20-inch soil proofed steel drainage pipe through the levee, 4.4 feet below the crown. Cobble revetted sump located on the waterside (WS). Siphon breaker in a 24-inch metal riser on the WS shoulder. Pump house at the landside (LS) toe. This crossing replaces the previous 18-inch pipe listed in the O&M manual, see DS_ID 17162. (Permit No. 13699, 1984 - Davis Ranches). [Additional Reference(s): USACE Sacramento O&M Manual 132, October 1959, (HLM 6.13)]. FS Date: 5/2/2017 2:36:30 PM

Pumphouse on LS slope.

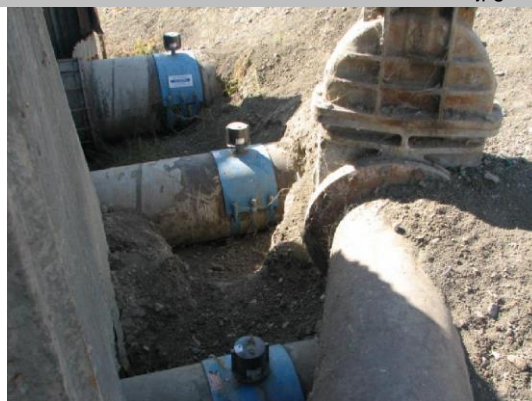
Photo 3 of 3 : UCIP\_FA\_2018\_51801\_69062.jpg

Comment Code						
Inspector Comment						
FS_ID:51801 DS_ID:20716 EP_NO: 13699 Repair Type: Non-Urgent Crossing Status: Found UCIP Comments: 5/2/2017 Pipe appears to be in good conition. Minor erosion above the LS pump house. (DWR Sutter Yard-AFreitag)10/17/2016 Crossing appears to be in good condition. (DWR Sutter Yard- AFreitag)5/31/2016 Crossing appears to be in good condition.5/4/2015 Corssing appears to be in good condition. No noticeable issues to report.6/17/2014 Same as last inspection.12/16/2013 Same as last inspection.7/16/2013 Same as last inspection.10/11/2012 Oil leaks at pump head. FIELD_STRUCT_DESC: 2 of 2: 20-inch soil proofed steel drainage pipe through the levee, 4.4 feet below the crown. Cobble revetted sump located on the waterside (WS). Siphon breaker in a 24-inch metal riser on the WS shoulder. Pump house at the landside (LS) toe. This crossing replaces the previous 18-inch pipe listed in the O&M manual, see DS_ID 17162. (Permit No. 13699, 1984 - Davis Ranches). [Additional Reference(s): USACE Sacramento O&M Manual 132, October 1959, (HLM 6.13)]. FS Date: 5/2/2017 2:36:30 PM

Pipes on LS slope.

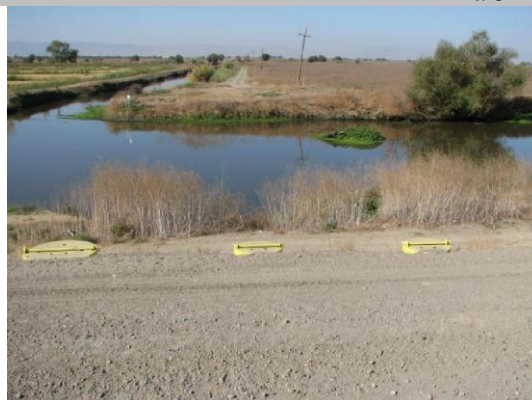
Photo 2 of 3 : UCIP\_FA\_2018\_51803\_69080.jpg

Comment Code						
Inspector Comment						
FS_ID:51803 DS_ID:17199 EP_NO: 9390 Repair Type: Non-Urgent Crossing Status: Found UCIP Comments: 5/2/2017 Pipe appears to be in good condition. Minor erosion above the LS pump house. (DWR Sutter Yard-AFreitag)10/17/2016 Crossing appears to be in good condition. (DWR Sutter Yard- AFreitag)5/31/2016 Crossing appears to be in good condition.5/4/2015 Corssing appears to be in good condition. No noticeable issues to report.6/17/2014 Same as last inspection.12/16/2013 Same as last inspection.7/16/2013 Same as last inspection.10/11/2012 Minor oil leak on pump. FIELD_STRUCT_DESC: 3 of 3: 18-inch steel drainage pipe through the levee, 4.4 feet below the crown. Cobble revetted sump located on the waterside (WS). Siphon breaker in a 16-inch metal riser on the WS shoulder. Pump house at the landside (LS) toe. (18-inch pipe authorized under Automatic Board Order (ABO) issued as Permit No. 9390, 1974 - Annie D. Propfe). [Additional Reference(s): DWR Levee Log, 2005. USACE Sacramento O&M Manual 132, October 1959, (HLM 6.13)]. FS Date: 5/2/2017 2:37:23 PM

Siphon breaker on WS shoulder.

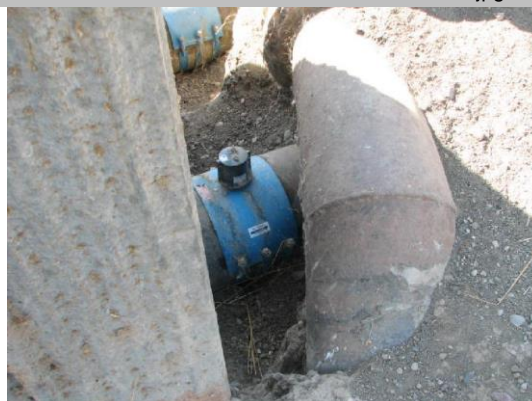
Photo 3 of 3 : UCIP\_FA\_2018\_51803\_69079.jpg

Comment Code						
Inspector Comment						
FS_ID:51803 DS_ID:17199 EP_NO: 9390 Repair Type: Non-Urgent Crossing Status: Found UCIP Comments: 5/2/2017 Pipe appears to be in good condition. Minor erosion above the LS pump house. (DWR Sutter Yard-AFreitag)10/17/2016 Crossing appears to be in good condition. (DWR Sutter Yard- AFreitag)5/31/2016 Crossing appears to be in good condition.5/4/2015 Corssing appears to be in good condition. No noticeable issues to report.6/17/2014 Same as last inspection.12/16/2013 Same as last inspection.7/16/2013 Same as last inspection.10/11/2012 Minor oil leak on pump. FIELD_STRUCT_DESC: 3 of 3: 18-inch steel drainage pipe through the levee, 4.4 feet below the crown. Cobble revetted sump located on the waterside (WS). Siphon breaker in a 16-inch metal riser on the WS shoulder. Pump house at the landside (LS) toe. (18-inch pipe authorized under Automatic Board Order (ABO) issued as Permit No. 9390, 1974 - Annie D. Propfe). [Additional Reference(s): DWR Levee Log, 2005. USACE Sacramento O&M Manual 132, October 1959, (HLM 6.13)]. FS Date: 5/2/2017 2:37:23 PM

Pipe at exit from pumphouse.

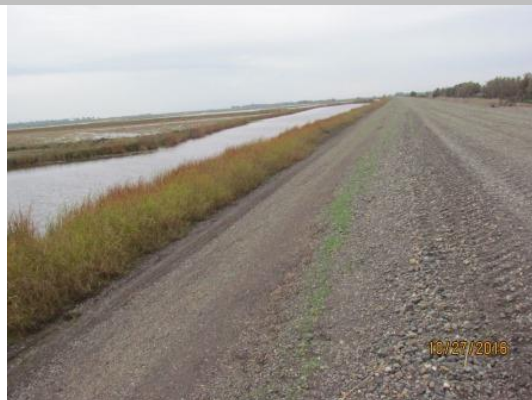
Photo 1 of 1 : FA\_2018\_MA0012\_299\_37\_20180904\_00004.jpg

LM Start	6.02	Rating **	U	Issue No.	37
LM End	7.20	Issue Type +	En	Location *	LS
Category	Earthen Levee			GPS Latitude/Longitude	
				Start	End
Item	Encroachments			39.115518 °	39.131618 °
				-122.017908 °	-122.022785 °
DWR ID	DWR_MA0012_01_f_2018_37				
Comment Code					
DT : Ditch					
Inspector Comment

View of a ditch along the landside toe.

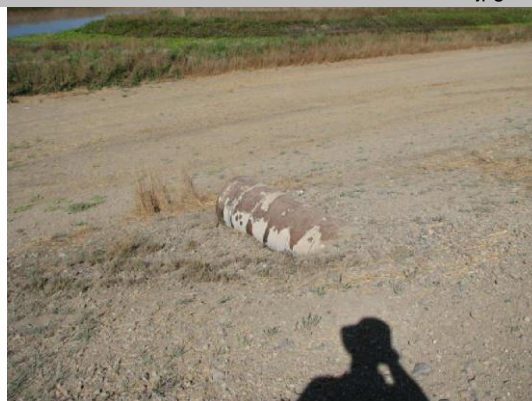
Photo 1 of 3 : UCIP\_FA\_2018\_51804\_69089.jpg

Comment Code						
Inspector Comment						
FS_ID:51804 DS_ID:17163 EP_NO: 9390 Repair Type: Non-Urgent Crossing Status: Found UCIP Comments: 5/2/2017 Appears abandoned- pipe capped on both ends. Should be removed. (DWR Sutter Yard- AFreitag)10/17/2016 Appears abandoned and should be removed. (DWR Sutter Yard- AFreitag)5/31/2016 Appears to be abandoned. Pipe is capped on both WS and LS ends.5/4/2015 Corssing appears to be in good condition. No noticeable issues to report.6/17/2014 Same as last inspection.12/16/2013 Same as last inspection.7/16/2013 Same as last inspection.10/11/2012 Rodent burrowing along sides of pipe on LS. FIELD_STRUCT_DESC: 24-inch steel irrigation pipe through the levee, 3 feet below the crown. Both ends capped, terminating on levee slopes. (Automatic Board Order (ABO) issued as Permit No. 9390, 1974 - Annie D. Propfe). [Additional Reference(s): DWR Levee Log, 2005. USACE Sacramento O&M Manual 132, October 1959, (HLM 7.76)]. FS Date: 5/2/2017 2:45:44 PM

Pipe on WS.

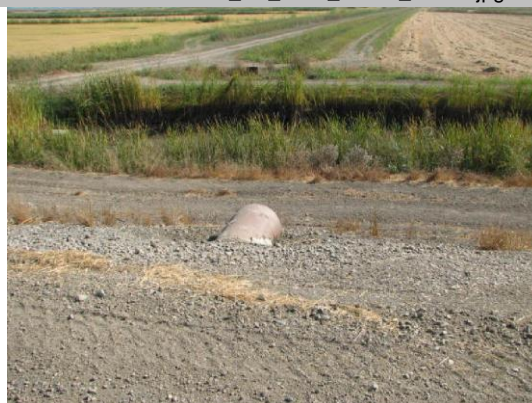
Photo 2 of 3 : UCIP\_FA\_2018\_51804\_69088.jpg

Pipe on LS.

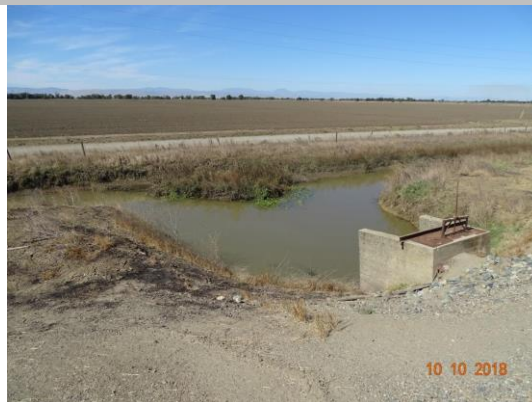
Photo 1 of 2 : FA\_2018\_MA0012\_299\_35\_20181011\_00086.jpg

LM Start	9.02	Rating **	A/W	Issue No.	35
LM End	9.04	Issue Type +	Ma	Location *	WS
Category	Supplemental			GPS Latitude/Longitude	
				Start	End
Item	2017 USACE Erosion Survey, DRAFT			39.157957 °	39.158226 °
				-122.021950 °	-122.021950 °
DWR ID	DWR_MA0012_01_f_2018_35				
Comment Code					
Inspector Comment					
2017 Site ID: SYC 9.3 L					
Status: Eroding					
2017 Field Notes: Access Issues - Could not observe					
Site History: 2011 - Erosion occurring upstream and downstream of an irrigation diversion structure.

View of diversion structure. Fall 2018.

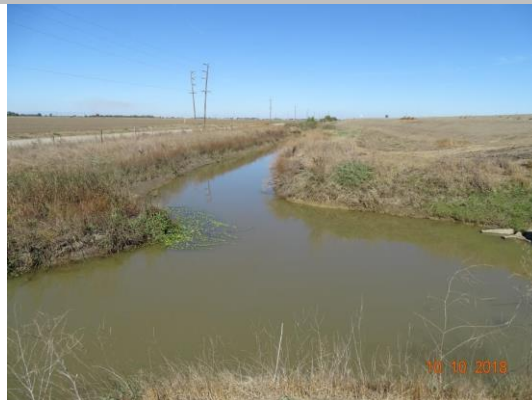
Photo 2 of 2 : FA\_2018\_MA0012\_299\_35\_20181011\_00088.jpg

LM Start	9.02	Rating **	A/W	Issue No.	35 (cont)
LM End	9.04	Issue Type +	Ma	Location *	WS
Category	Supplemental			GPS Latitude/Longitude	
				Start	End
Item	2017 USACE Erosion Survey, DRAFT			39.157957°	39.158226°
				-122.021950°	-122.021950°
DWR ID	DWR_MA0012_01_f_2018_35				
Comment Code					
Inspector Comment					
2017 Site ID: SYC 9.3 L					
Status: Eroding					
2017 Field Notes: Access Issues - Could not observe					
Site History: 2011 - Erosion occurring upstream and downstream of an irrigation diversion structure.

Upstream view of Colusa Basin from the diversion structure. Fall 2018.

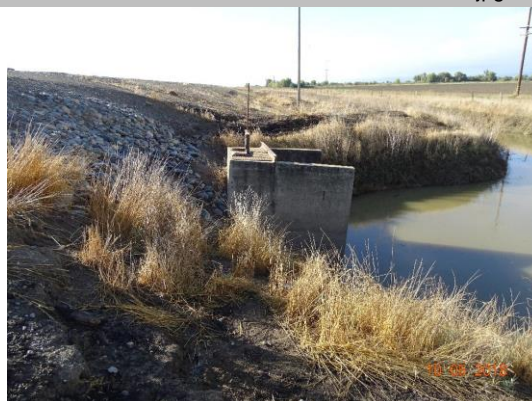
Photo 1 of 3 : UCIP\_FA\_2018\_53012\_78206.jpg

Comment Code						
Inspector Comment						
FS_ID:53012 DS_ID:17166 EP_NO: 9390 Repair Type: Urgent Crossing Status: Found UCIP Comments: 10/5/2018 Longitudinal crack observed on C-shaped headwall on WS which is tilting away from levee. Progressing erosion around headwall was observed on WS. Crossing is a part of DWR FSRP inspection. (O.Yakimov - DWR)5/2/2017 Ws headwal still appears to be tilting away from the levee. No wheel to operate the WS slidegate. (DWR Sutter Yard- AFreitag)10/17/2016 WS concrete headwall is still tiltig away from the levee. (DWR Sutter Yard- AFreitag)5/31/216 Ws concrete headwall is still tilting away from the levee and towards the WS ditch. (DWR Sutter Yard - afreitag)5/4/2015 WS concrete headwall tilting away from the levee slope. (DWR Sutter Yard - afreitag)6/17/2014 Same as last inspection. (DWR Sutter Yard - afreitag)12/16/2013 Same as last inspection. (DWR Sutter Yard - afreitag)7/16/2013 Same as last inspection. (DWR Sutter Yard - afreitag)10/11/2012 Concrete Headwall tilting on WS slope. (DWR UCIP - wwylie) FIELD_STRUCT_DESC: 36-inch corrugated metal drainage pipe through the levee, 15 feet below the crown. Concrete headwall, slide gate, and grouted revetment on the waterside (WS). Slide gate and concrete headwall on the landside (LS). (36-inch pipe authorized under Automatic Board Order (ABO) issued as Permit No. 9390, 1974 - Annie D. Propfe). [Additional Reference(s): DWR Levee Log, 2005. USACE Sacramento O&M Manual 132, October 1959, (HLM 9.24)]. FS Date: 10/5/2018 2:55:04 PM

Headwall at WS toe.

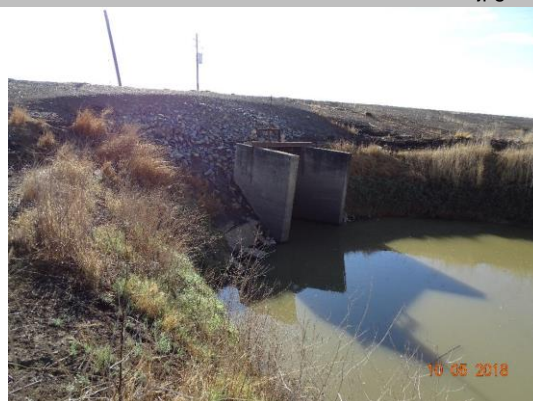
Photo 2 of 3 : UCIP\_FA\_2018\_53012\_78208.jpg

Comment Code						
Inspector Comment						
FS_ID:53012 DS_ID:17166 EP_NO: 9390 Repair Type: Urgent Crossing Status: Found UCIP Comments: 10/5/2018 Longitudinal crack observed on C-shaped headwall on WS which is tilting away from levee. Progressing erosion around headwall was observed on WS. Crossing is a part of DWR FSRP inspection. (O.Yakimov - DWR)5/2/2017 Ws headwal still appears to be tilting away from the levee. No wheel to operate the WS slidegate. (DWR Sutter Yard- AFreitag)10/17/2016 WS concrete headwall is still tiltig away from the levee. (DWR Sutter Yard- AFreitag)5/31/216 Ws concrete headwall is still tilting away from the levee and towards the WS ditch. (DWR Sutter Yard - afreitag)5/4/2015 WS concrete headwall tilting away from the levee slope. (DWR Sutter Yard - afreitag)6/17/2014 Same as last inspection. (DWR Sutter Yard - afreitag)12/16/2013 Same as last inspection. (DWR Sutter Yard - afreitag)7/16/2013 Same as last inspection. (DWR Sutter Yard - afreitag)10/11/2012 Concrete Headwall tilting on WS slope. (DWR UCIP - wwylie) FIELD_STRUCT_DESC: 36-inch corrugated metal drainage pipe through the levee, 15 feet below the crown. Concrete headwall, slide gate, and grouted revetment on the waterside (WS). Slide gate and concrete headwall on the landside (LS). (36-inch pipe authorized under Automatic Board Order (ABO) issued as Permit No. 9390, 1974 - Annie D. Propfe). [Additional Reference(s): DWR Levee Log, 2005. USACE Sacramento O&M Manual 132, October 1959, (HLM 9.24)]. FS Date: 10/5/2018 2:55:04 PM

Overview of headwall at WS toe.

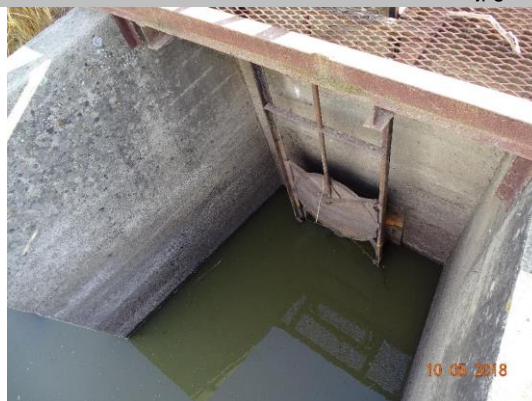
Photo 3 of 3 : UCIP\_FA\_2018\_53012\_78209.jpg

UCIP Comments: 10/5/2018 Longitudinal crack observed on C-shaped headwall on WS which is tilting away from levee. Progressing erosion around headwall was observed on WS. Crossing is a part of DWR FSRP inspection. (O.Yakimov - DWR)5/2/2017 Ws headwal still appears to be tilting away from the levee. No wheel to operate the WS slidegate. (DWR Sutter Yard- AFreitag)10/17/2016 WS concrete headwall is still tiltig away from the levee. (DWR Sutter Yard- AFreitag)5/31/216 Ws concrete headwall is still tilting away from the levee and towards the WS ditch. (DWR Sutter Yard - afreitag)5/4/2015 WS concrete headwall tilting away from the levee slope. (DWR Sutter Yard - afreitag)6/17/2014 Same as last inspection. (DWR Sutter Yard - afreitag)12/16/2013 Same as last inspection. (DWR Sutter Yard - afreitag)7/16/2013 Same as last inspection. (DWR Sutter Yard - afreitag)10/11/2012 Concrete Headwall tilting on WS slope. (DWR UCIP - wwylie)

Inside view of concrete headwall and slidegate at WS toe.

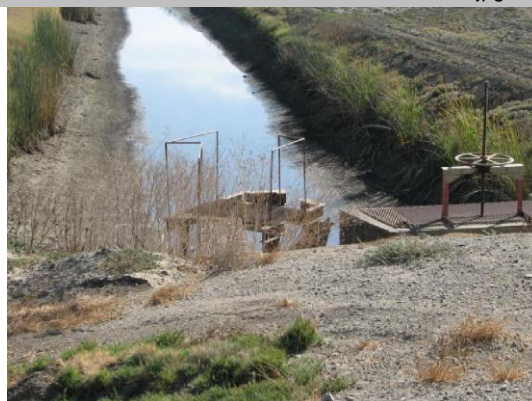
Photo 1 of 3 : UCIP\_FA\_2018\_51807\_69109.jpg

Comment Code						
Inspector Comment						
FS_ID:51807 DS_ID:17165 EP_NO: 9390 Repair Type: Non-Urgent Crossing Status: Indicator Found UCIP Comments: 5/2/2017 Abandoned- only LS steel walkway is visible. (DWR Sutter Yard- AFreitag)10/17/2016 Abandoned. (DWR Sutter Yard- AFreitag)5/31/2016 Abandoned crossing.5/4/2015 Abandoned crossing.6/17/2014 Same as last inspection.12/16/2013 Same as last inspection.7/16/2013 Same as last inspection.10/11/2012 Pipe abandoned. Steel pump platform remains on LS slope, but all appurtances have been removed. FIELD_STRUCT_DESC: *ABANDONED* 18-inch steel drainage pipe through the levee, 3 feet below the crown. Waterside (WS) end open into concrete spill box. Pump located on the landside (LS) on steel pier. (18-inch pipe authorized under Automatic Board Order (ABO) issued as Permit No. 9390, 1974 - Annie D. Propfe). [Additional Reference(s): DWR Levee Log, 2005. USACE Sacramento O&M Manual 132, October 1959, (HLM 9.24)]. FS Date: 5/2/2017 2:47:45 PM

Pump platform at center left of photo.

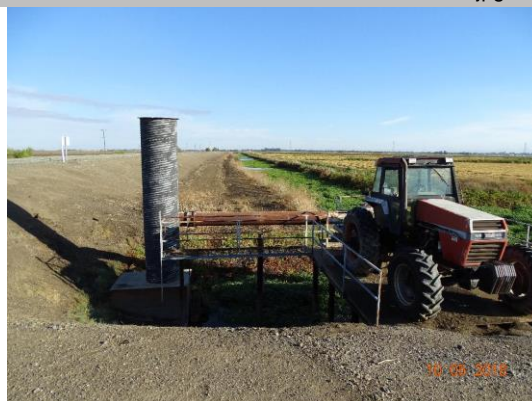
Photo 1 of 3 : UCIP\_FA\_2018\_53013\_78165.jpg

UCIP Comments: 10/5/2018 Flap gate was installed at WS end of the pipe. Pipe is excessively corroded looking inside from WS end. Video inspection is recommended. Cracks more than 1-inch wide were observed on WS slope around pipe alignment that may be a sign of slope instability. (O.Yakimov - DWR)5/2/2017 No repairs have been made to this crossing yet. WS flap gate is still disconnected from end of pipe and pipe is showing heavy signs of rust and deterioration as far in as i can see from the WS end. Pipe should be internally camera inspected and repaired/replaced. (DWR Sutter Yard-AFreitag)01/31/2017 Informal Notice of Violation (NOV) was sent out January 31, 2017 by DWR Flood Maintenance Office--owner needs to re-attach flap gate to drainage pipe and coordinate with CVFPB to address additional issue(s) identified in NOV. Owner has until Monday February 27th, 2017 to repond to DWR contact: Bryan Reniff. (refer to Official Notice for details). (DWR UCIP - O. Magana) 10/17/2016 WS flapgate has seperated from the pipe end. WS pipe end is showing signs of rust and deterioration. Needs a new flapgate or other means of closing off the pipe before flood season. (DWR Sutter Yard-AFreitag)5/31/2016 Crossing appears to be in good condition.5/4/2015 Corssing appears to be in good condition. No noticeable issues to report.6/17/2014 Same as last inspection.12/16/2013 Same as last inspection.7/16/2013 Same as last inspection.

Pumping plant at LS toe.

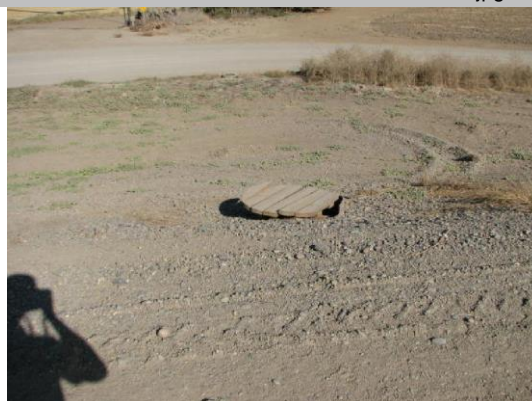
Photo 1 of 2 : UCIP\_FA\_2018\_51810\_69115.jpg

Comment Code						
Inspector Comment						
FS_ID:51810 DS_ID:17157 EP_NO: 9386 Repair Type: Non-Urgent Crossing Status: Found UCIP Comments: 5/2/2017 Abandoned- needs to be done properly. (DWR Sutter Yard- AFreitag)10/17/2016 Abandoned crossing. (DWR Sutter Yard- AFreitag)5/31/2016 Abandoned crossing. Both pipe ends and slide gate inside of riser are buried.5/4/2015 Both pipe ends and slide gate in riser are plugged with soil. Crossing is inoperable.6/17/2014 Same as last inspection.12/16/2013 Same as last inspection.7/16/2013 Same as last inspection.10/11/2012 Pipe plugged with soil on both ends as well as at slide gate on WS slope. Slide gate inoperable. FIELD_STRUCT_DESC: *ABANDONED* 24-inch corrugated metal drainage pipe through the levee, 8 feet below the crown. Slide gate in a 36-inch riser on the waterside (WS) shoulder. Levee turns eastward. (24-inch pipe [HLM 11.17] authorized under Automatic Board Order (ABO) issued as Permit No. 9386, 1974 - C. J. Wescott Jr.). [Additional Reference(s): DWR Levee Log, 2005. USACE Sacramento O&M Manual 132, October 1959, (HLM 11.17)]. FS Date: 5/2/2017 2:51:53 PM

cover on 36-inch CMP standpipe on WS slope.
